Manhole Inspection Summary

Manhole # S11O__014MH

Location Address: **3061 Stafford St**

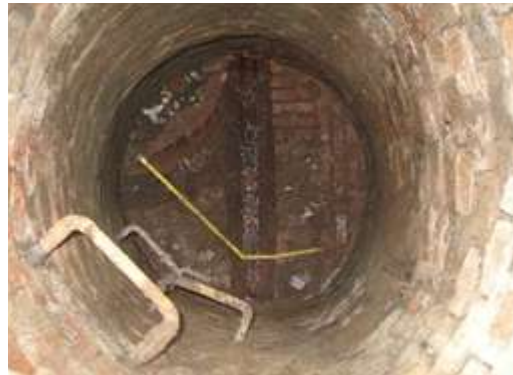
Top View

Debris on bench

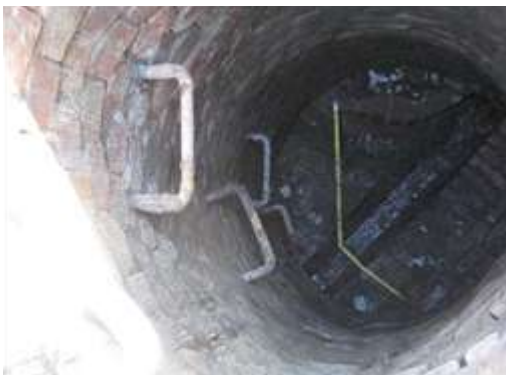
Defect 1

Steps Count: **4** Missing: **0** ☒ **Corroded**

Corroded steps

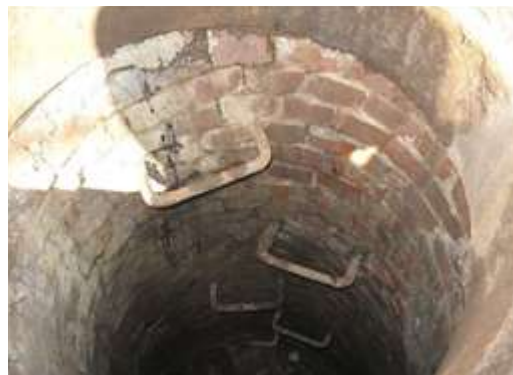
Defect 3

Condition: ☐ Sound ☐ Cracked ☐ Root Intrusion ☐ Loose Brick ☒ **Deteriorated**

Infiltration: ☐ None ☐ Joint ☐ Cracks ☐ Mortar ☐ Roots ☒ **Wall**

Deteriorating mortar along chimney and corbel wall, signs of infiltration

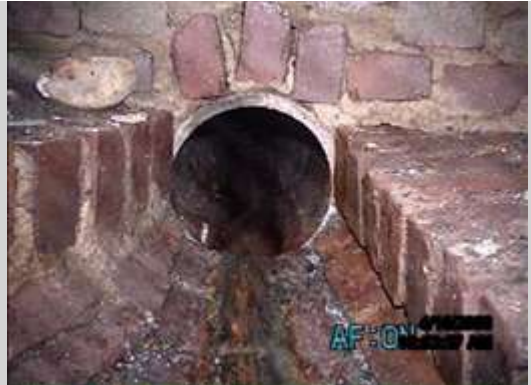
12 O'Clock Outflow

Pipe Height: **8.4** (in.) Rod and Bar (Angled)
Pipe Material: **Clay** ☐ Pipe Lined
Invert Depth: **9.80** (ft.) Flow Characteristics: **Fast**
Deposits: ☒ None ☐ Mud ☐ ~~Gravy~~ ☐ Debris ☐ Grease
Silt Depth: **0** (in.) Deposits Extent:
Infiltration: **None** Pipe Seal Cond: **Sound**

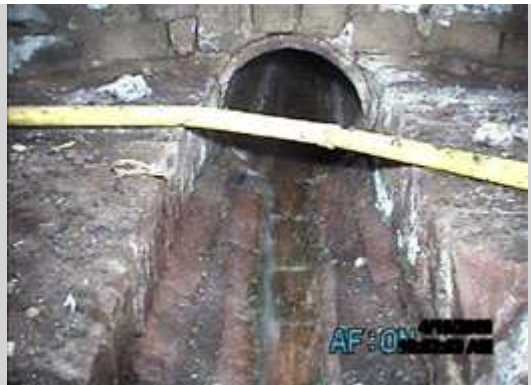
6 O'Clock Inflow

Pipe Height: **8.4** (in.) Rod and Bar (Angled)
Pipe Material: **Clay** ☐ Pipe Lined
Invert Depth: **9.98** (ft.) Flow Characteristics: **Fast**
Deposits: ☒ None ☐ Mud ☐ ~~Gravy~~ ☐ Debris ☐ Grease
Silt Depth: **0** (in.) Deposits Extent:
Infiltration: **None** Pipe Seal Cond: **Sound**

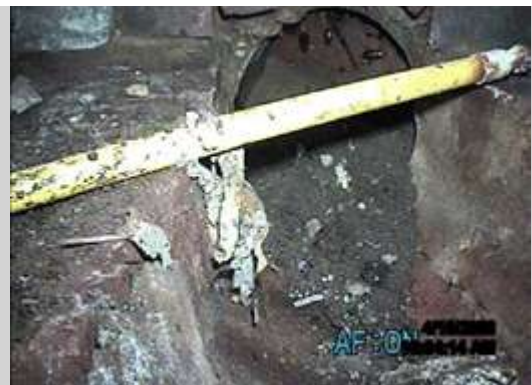
9 O'Clock Inflow

service line not on map 11O MH 014
(clogged)
no flow

Invert Depth: **9.74** (ft.) Flow Characteristics: **None**

Deposits: ☐ None ☐ Mud ☒ **Sludge** ☐ Debris ☐ Grease

Silt Depth: **4** (in.) Deposits Extent: **Heavy**

Connects To: **Stub connection / abandoned**

Comments **Cleaning required at 9 Oclock pipe**
